TECHNICAL REPORT M-321
August 1982

COATINGS AND CATHODIC PROTECTION OF PILING
IN SEAWATER: RESULTS OF 10-YEAR EXPOSURE
AT LACOSTA ISLAND, FL

by
J. Bukowski
A. Kumar

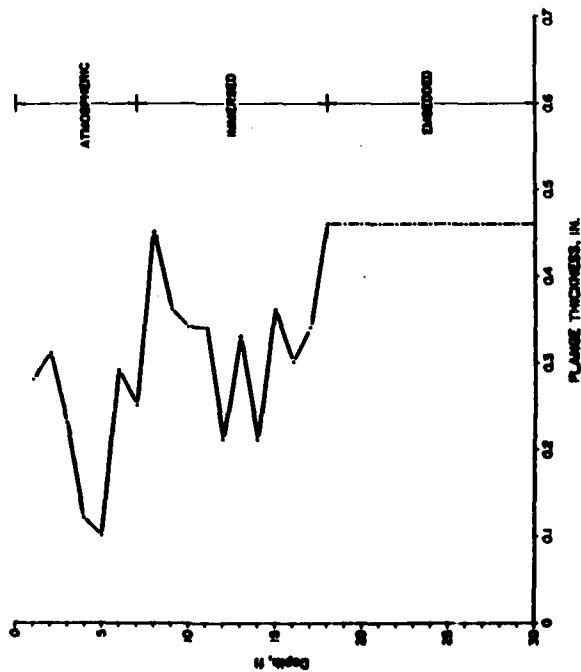
Figure 10. Flange thickness for pile 1B, bare carbon steel (metric conversion factors:
1 in. = 25.4 mm; 1 ft = 0.3048 m).

All piling of bare carbon and mariner steel showed perforation of the web in the atmospheric zone. No significant differences in corrosion rates were noted between the bare carbon and mariner steel after 10-years' exposure at the LaCosta Island test site. The bare steel piles were severely corroded directly above the high tide (splash) zone and just below the low tide area. A zone of severe corrosion also was found at or just below the piling's mud line. The bare steel piling exhibited very little corrosion in the embedded zone.

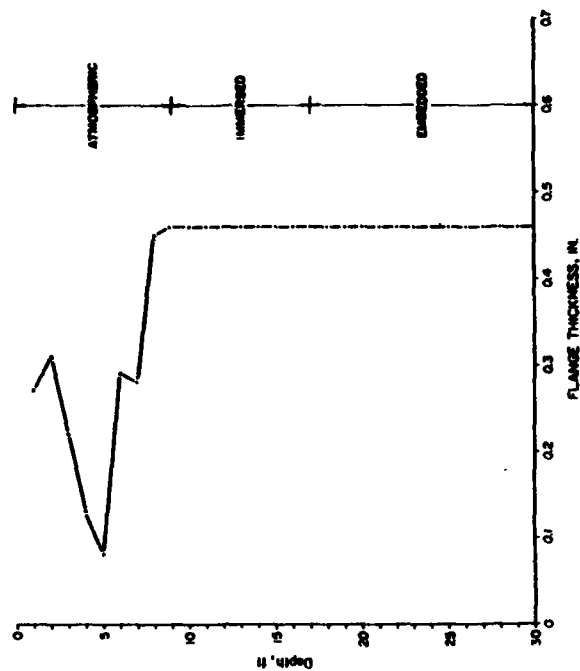
Figure 13. Flange thickness for pile 3B, bare carbon steel with aluminum anodes (metric conversion factors: 1 in. = 25.4 mm; 1 ft = 0.3048 m).

Using sacrificial zinc or aluminum anodes on bare steel piling (Figures 12, 13, and 14) effectively reduced the corrosion rate in the immersed and embedded

zones to less than 0.1 mil (0.003 mm) per year, but had no effect on corrosion in the atmospheric and splash zones.

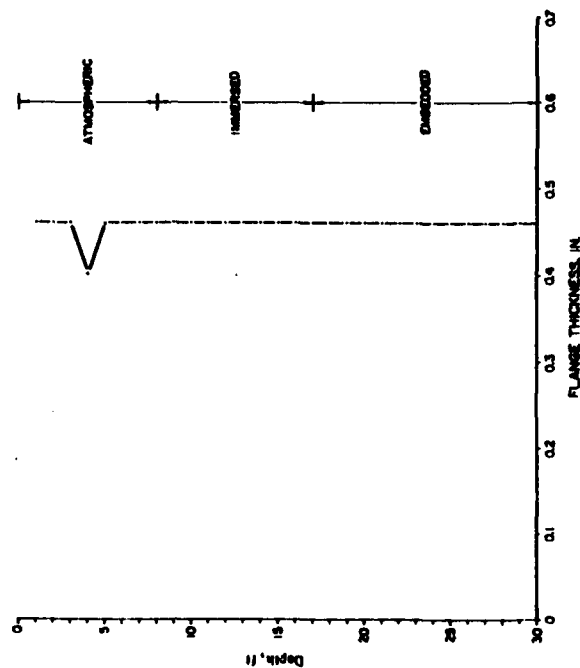
Figure 15. Flange thickness for pile 5B, coal-tar epoxy with zinc anodes (metric conversion factors: 1 in. = 25.4 mm; 1 ft = 0.3048 m).

System 5 was a coal-tar epoxy coating with zinc anodes. The organic coal-tar epoxy coating provided adequate protection to the exposed pile in the atmospheric zone. The immersed zone suffered severe loss of the organic coating, but the steel pile was in excellent condition because of the cathodic protection provided by the sacrificial zinc anodes.

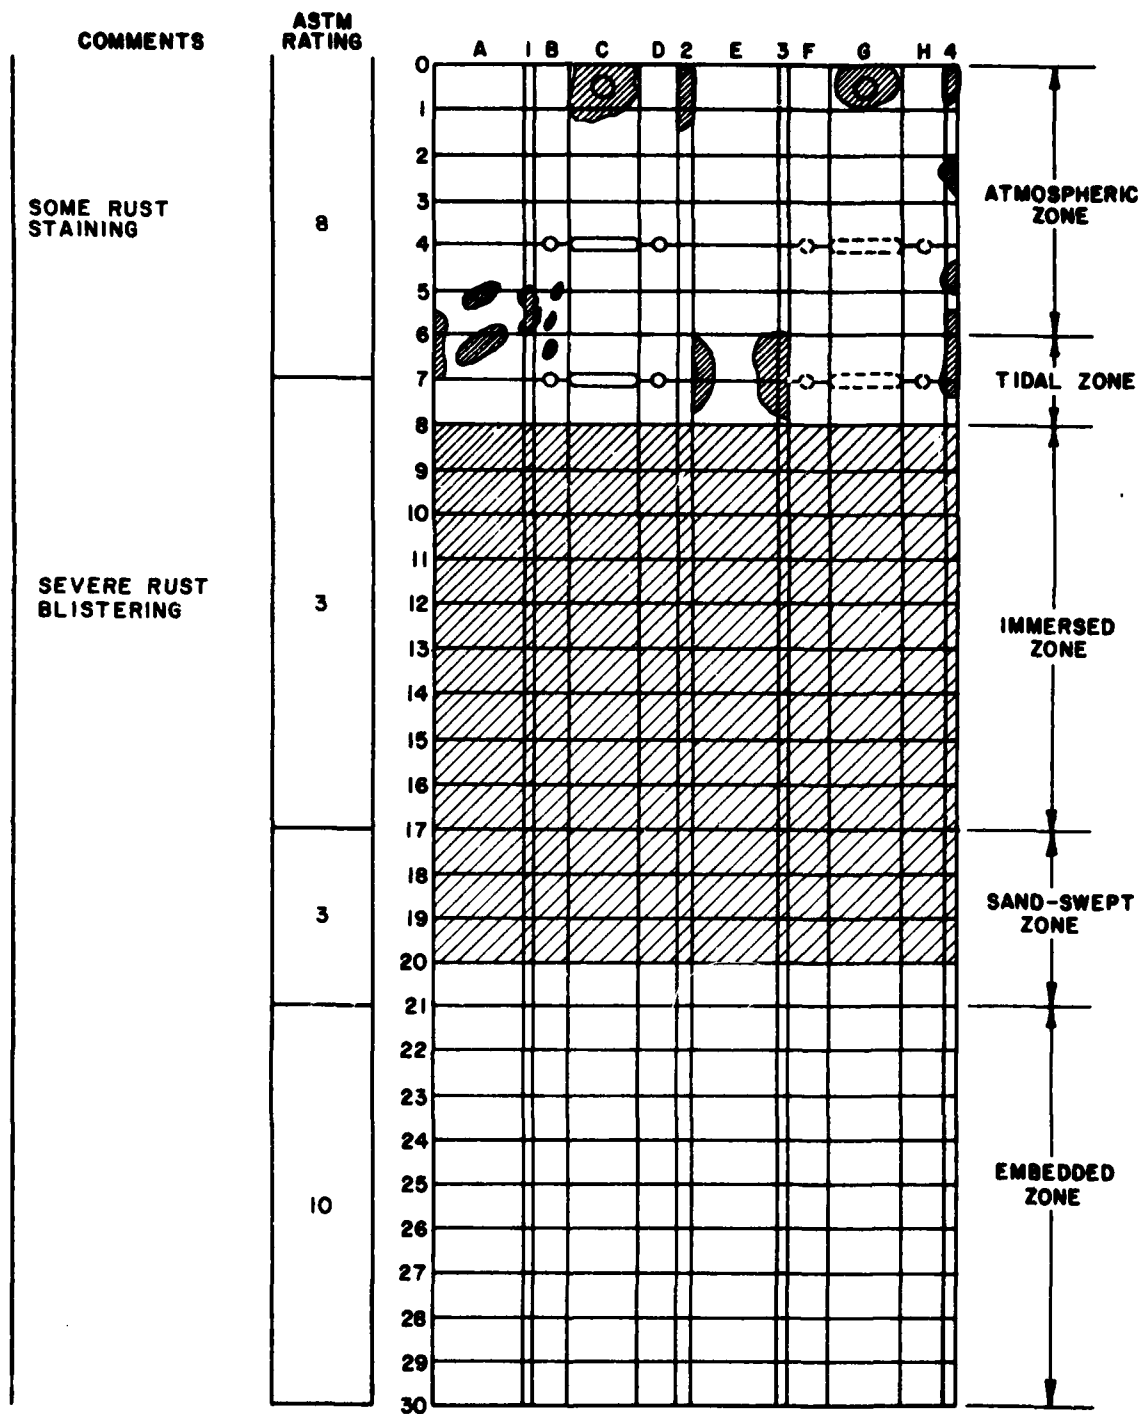
PILE NO. 4A

1. System 4 was a C-200 coal-tar epoxy coating. This system showed some rusting in the atmospheric zone. Rusting and pitting with loss of coating, especially at the flange, was present in the immersed zone edge. In the immersed zone, there was attached marine growth.

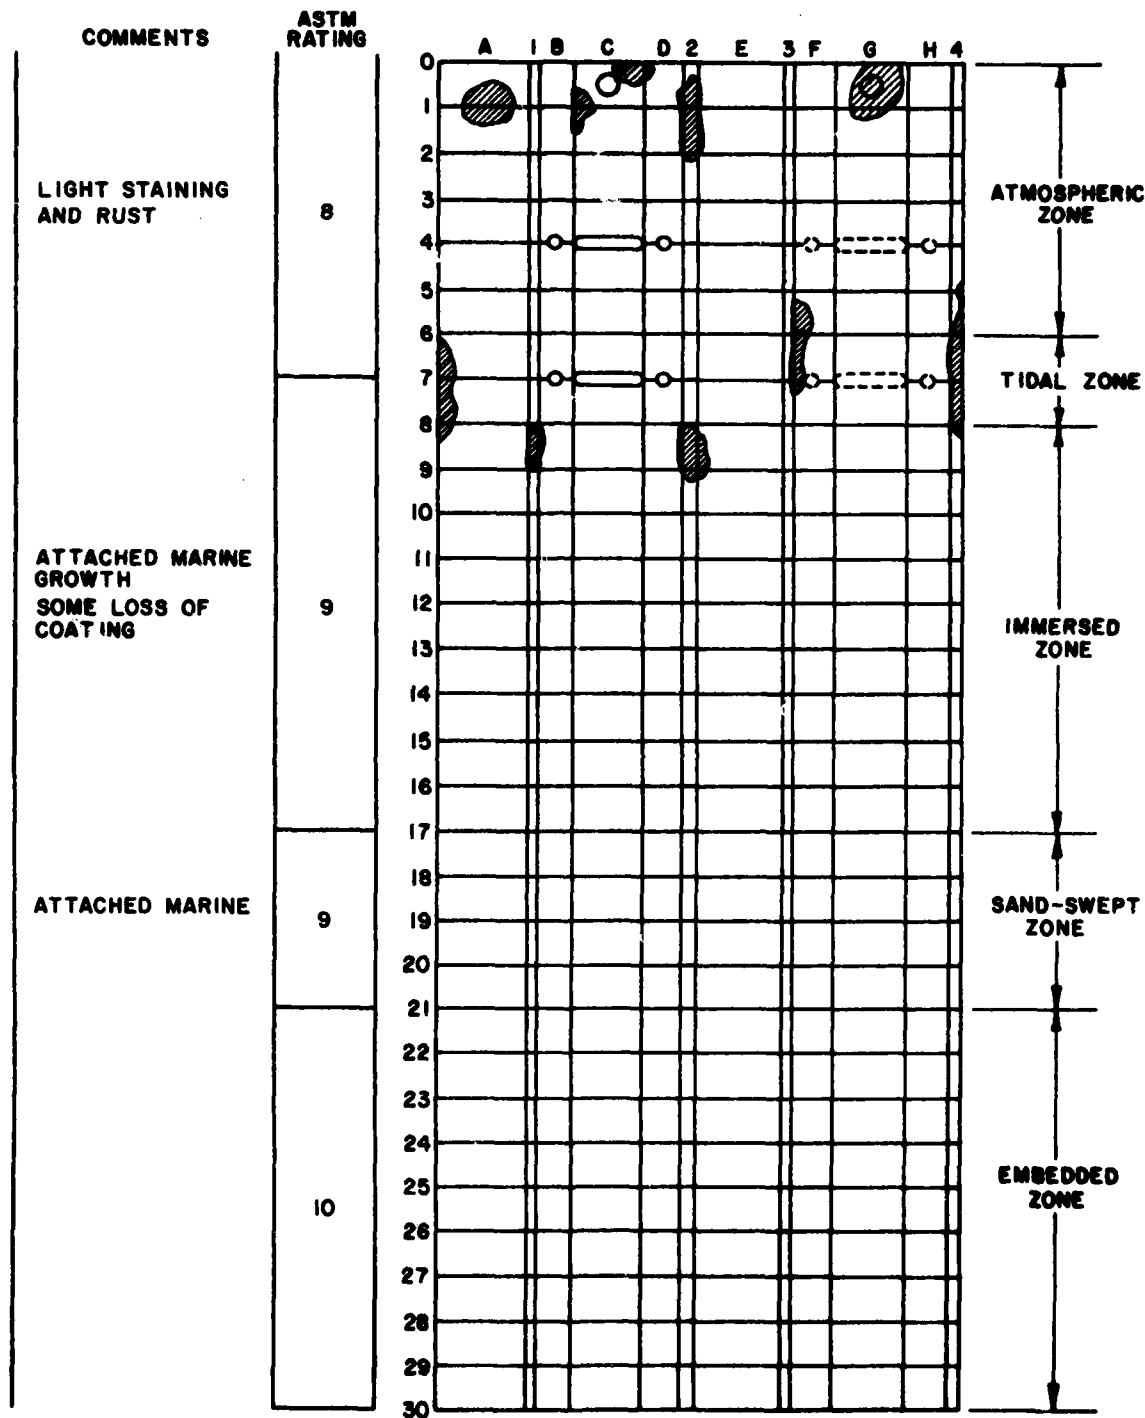
PILE NO. 5A

2. System 5 was a C-200 coal-tar epoxy/polyamide-cured coating with zinc anodes. Light rust and scale were present in atmospheric zone, with some loss of the coating in the immersed zone.

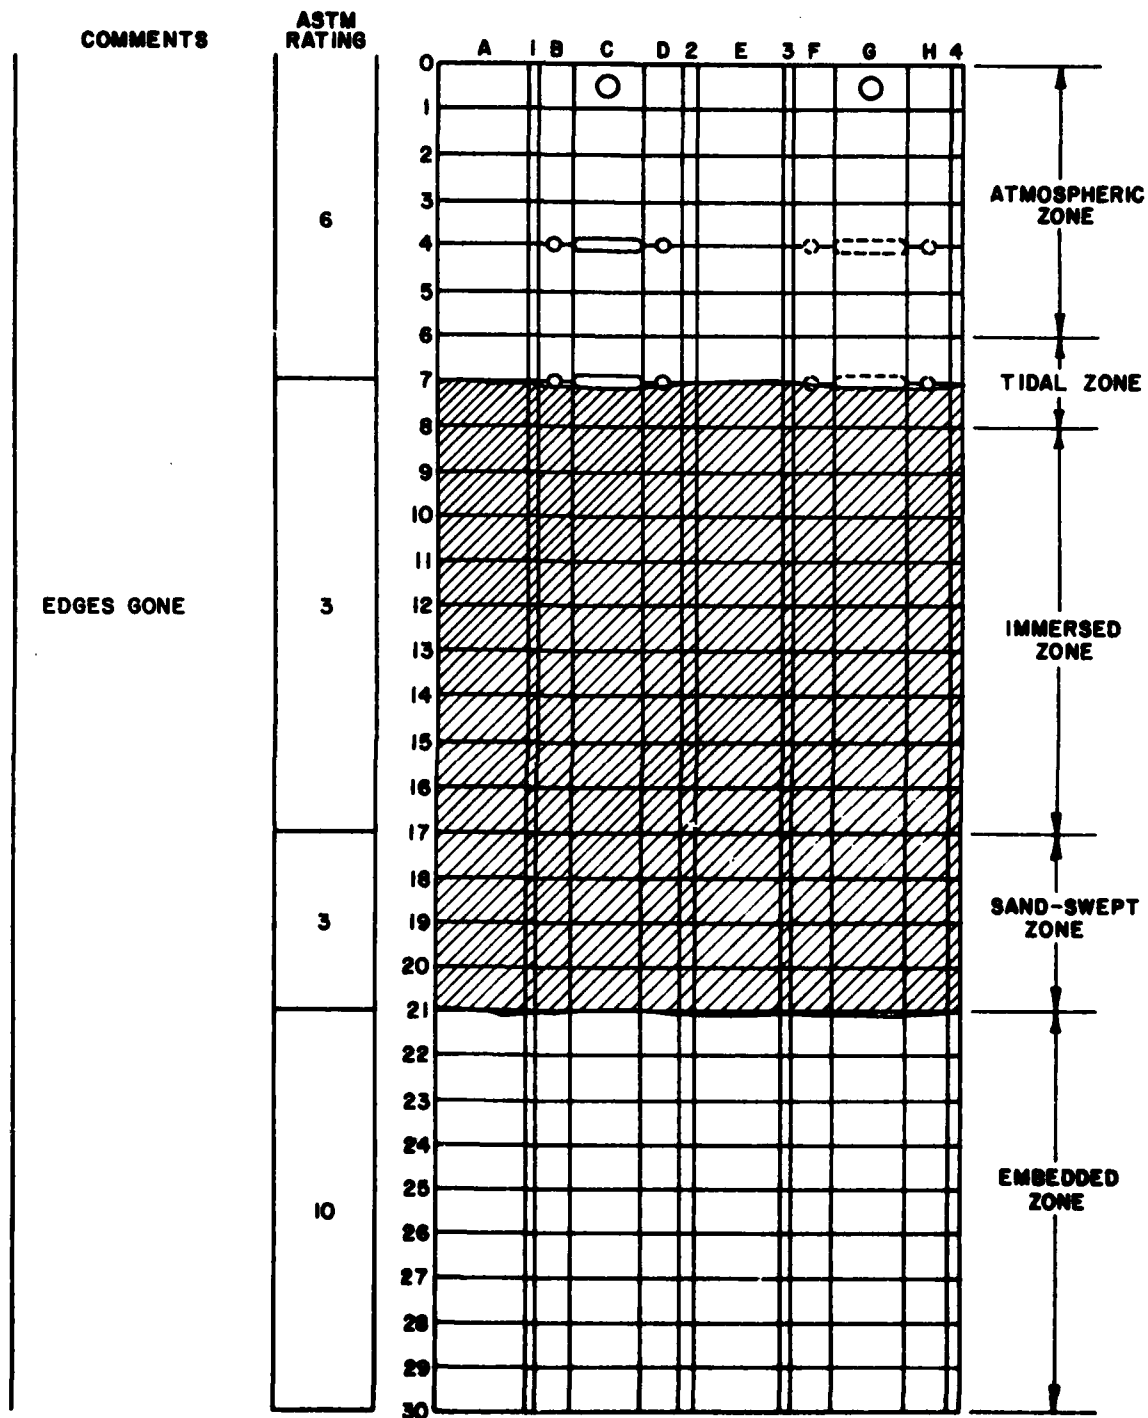
PILE NO. 6A

3. System 6 was a coal-tar epoxy/amine-cured coating. Severe loss of coating in the immersed zone occurred. Some rust and scale were in the atmospheric zone.

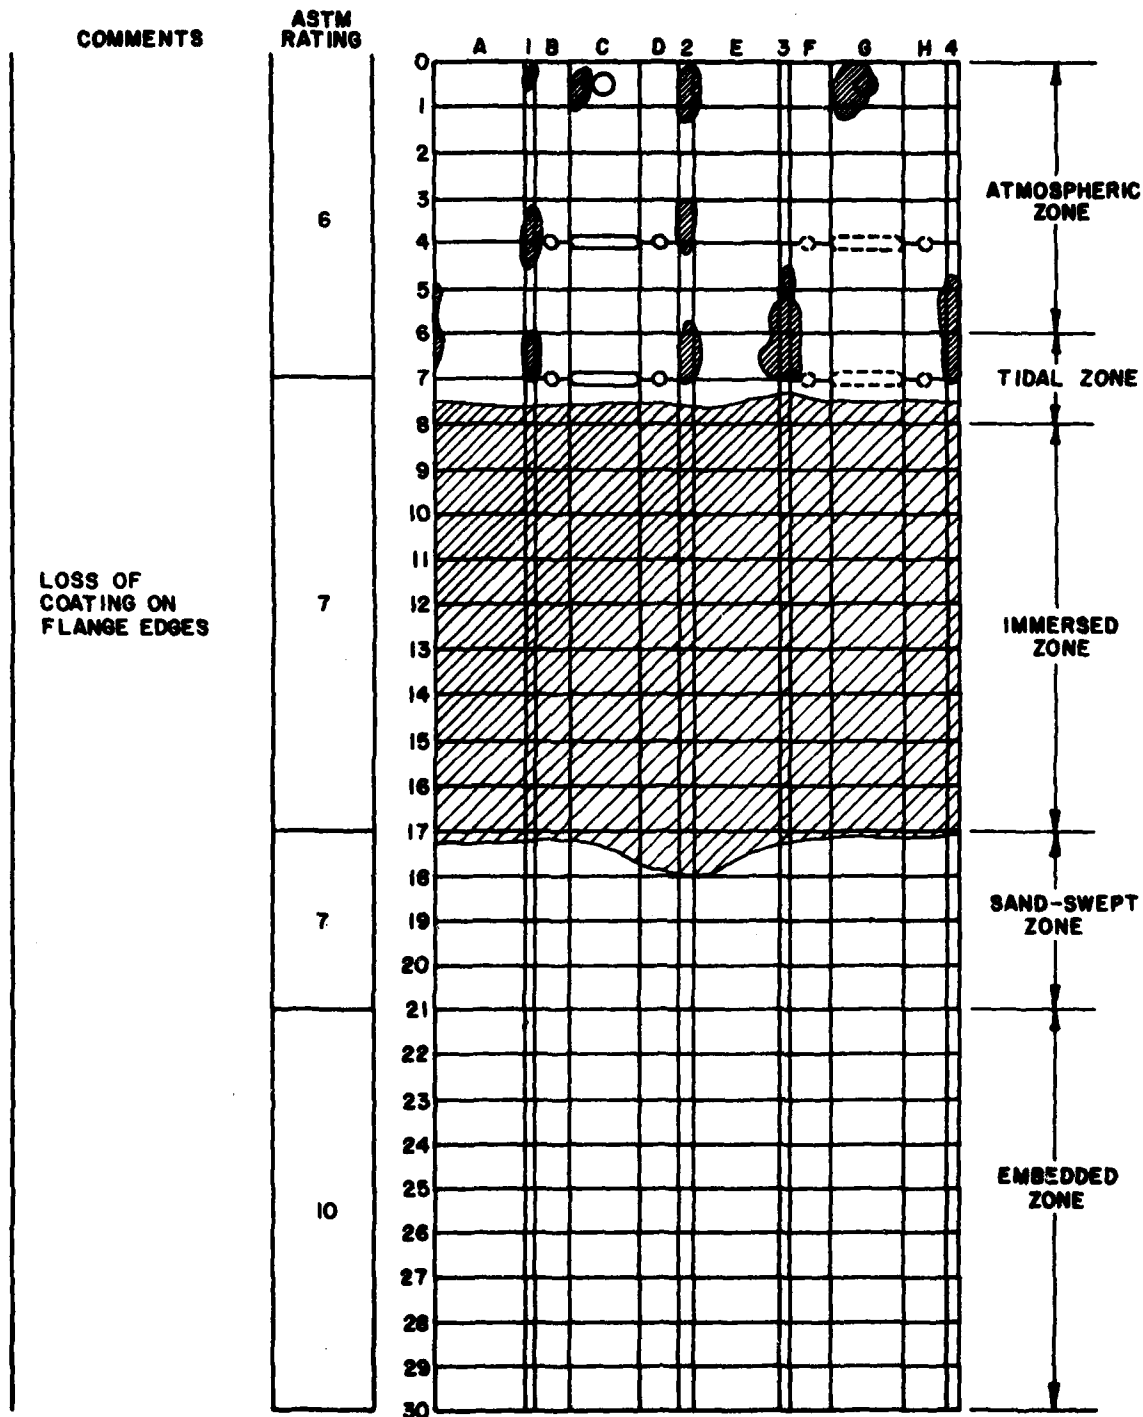
PILE NO. 7A

4. System 7 was a C-200 coal-tar epoxy coating with aluminum oxide grit added to the final coat of C-200 coal-tar epoxy along the mudline. Light rust and scale were in the atmospheric zone, with some loss of coating in the immersed zone.

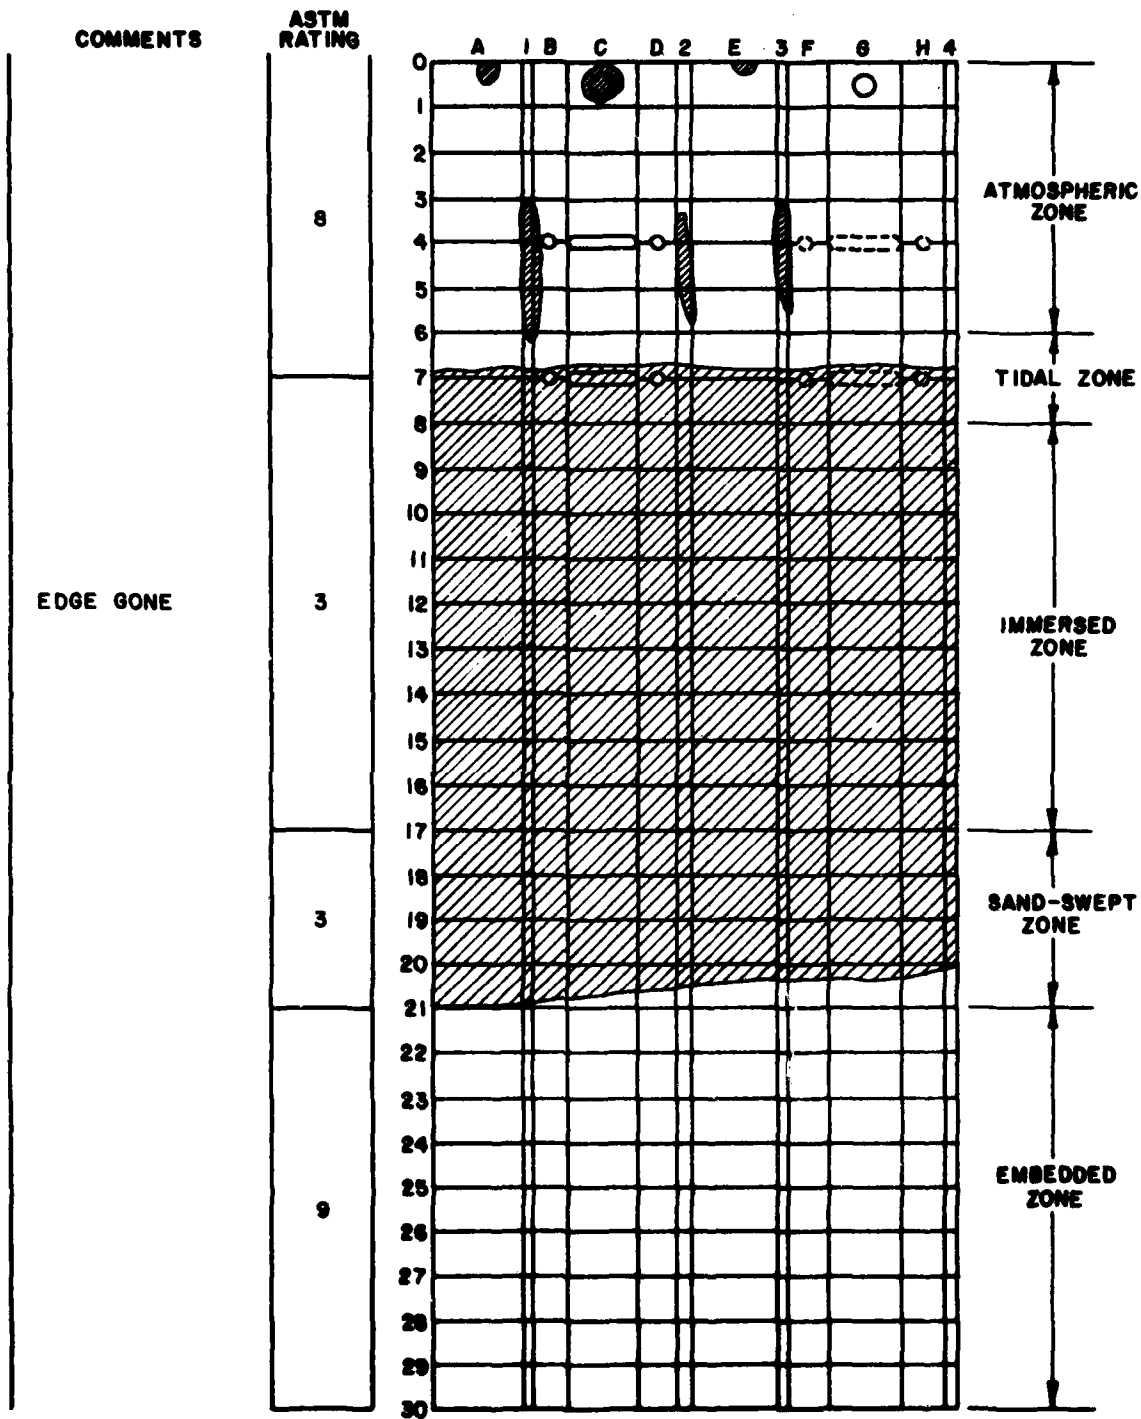
PILE NO. 8A

5. System 8 consisted of an aluminum pigmented epoxy-tar applied over two coats of epoxy tar. There was light rusting along the flange edges in the atmospheric zone. The immersed zone was severely rusted and pitted.

The one system in the metal-filled class—aluminum pigmented epoxy-tar—performed poorly in the immersed and sand-swept zones. This was a three-coat system in which two coats of epoxy-tar electrically insulated, thus preventing the outer coat containing the aluminum pigment from sacrificially protecting the steel pile. The coating was perforated by barnacles, which caused severe pitting in the immersed zone.

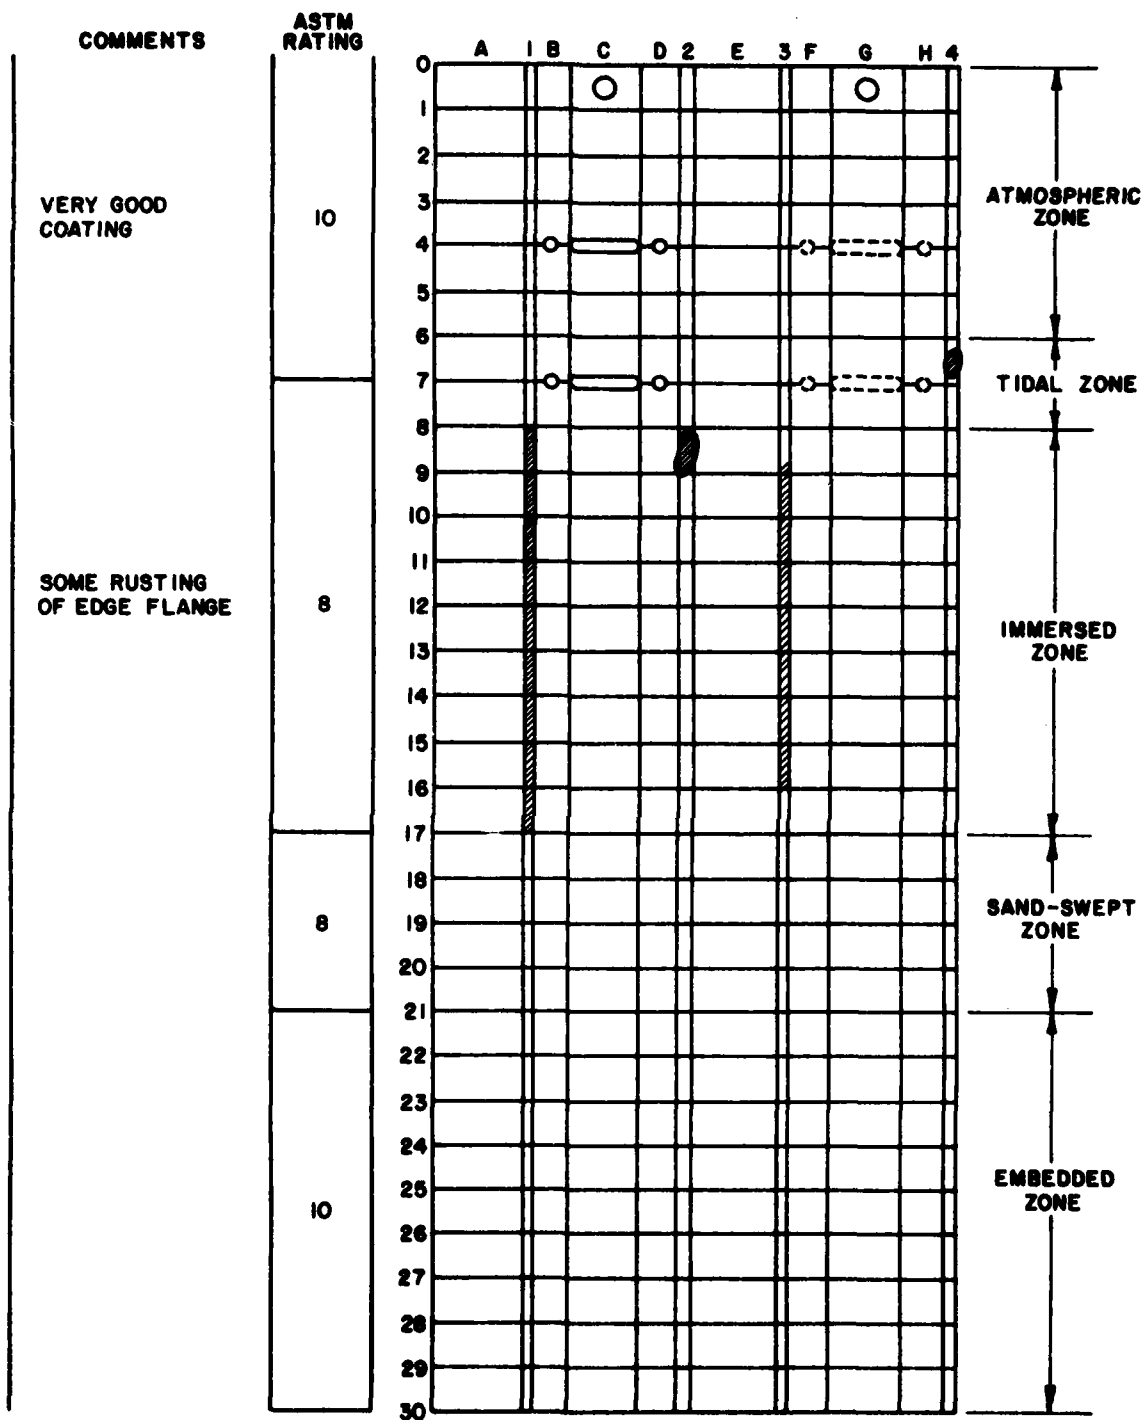
PILE NO. 9A

6. System 9 was an epoxy primer/coal-tar epoxy. This coating system was in excellent condition in the atmospheric zone. There was some rusting of flange edges in the immersed zone.

EDGE IS
EXTREMELY
CORRODED

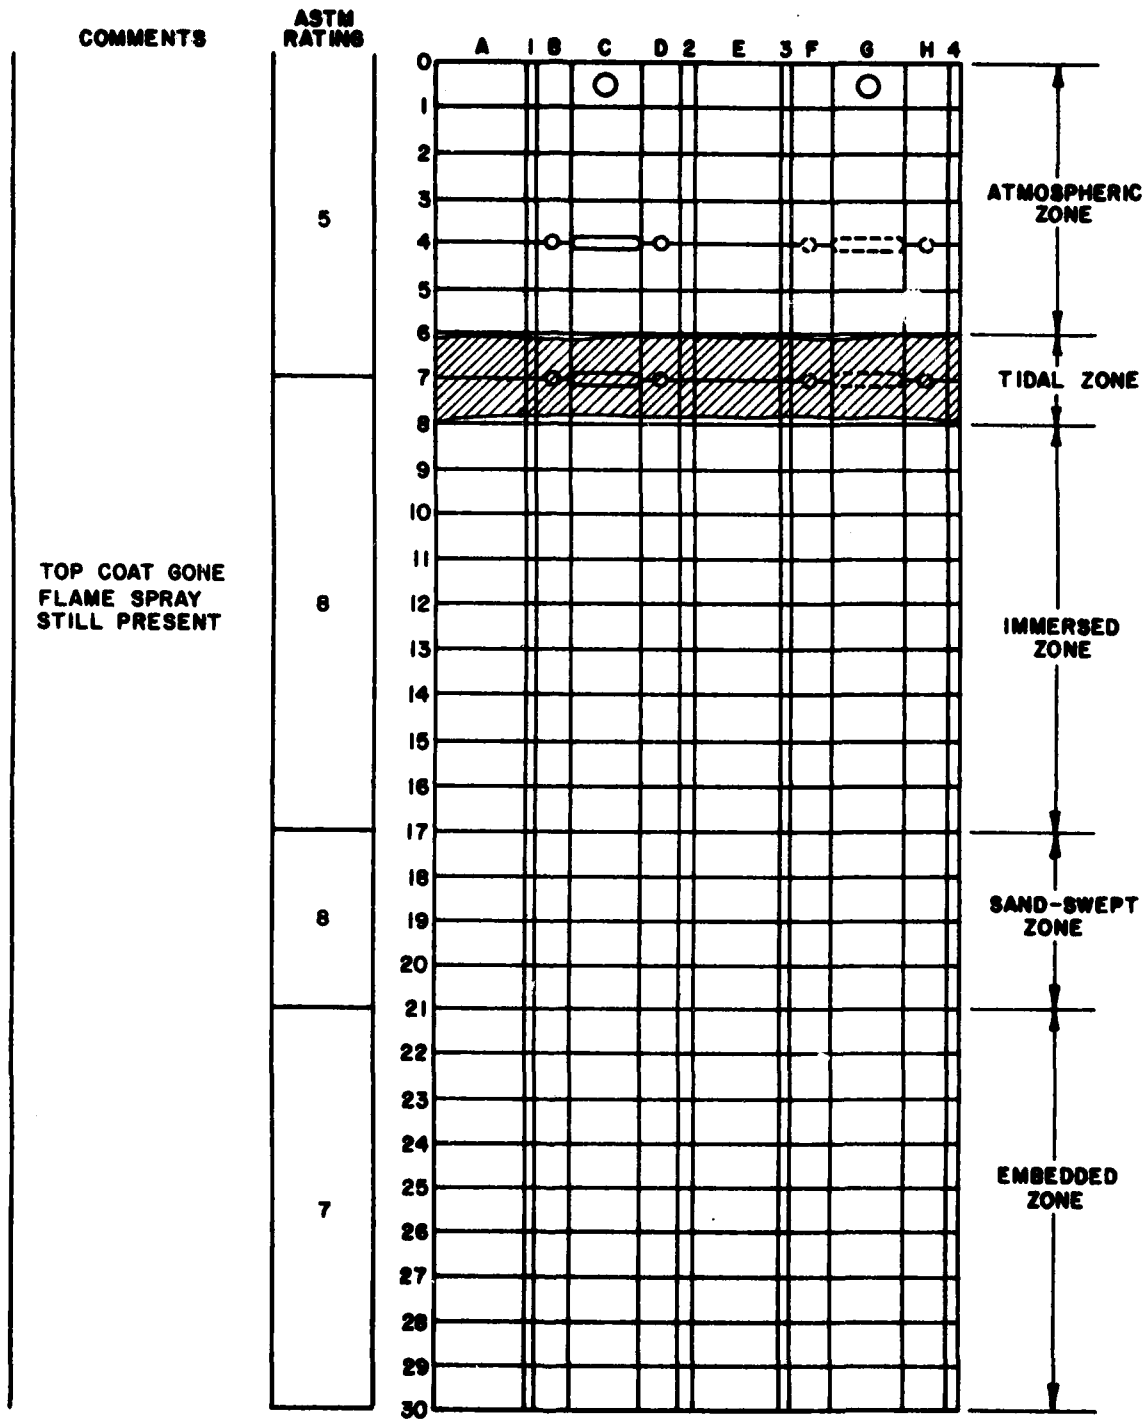
PILE NO. 15A

12. System 15 was a flame-sprayed zinc coating with a saran topcoat. Staining and light rust were present in the atmospheric zone. The saran topcoat was completely gone from the immersed zone, but the flame-sprayed zinc still provided protection.

TOP COAT GONE
FLAME SPRAY
STILL PRESENT

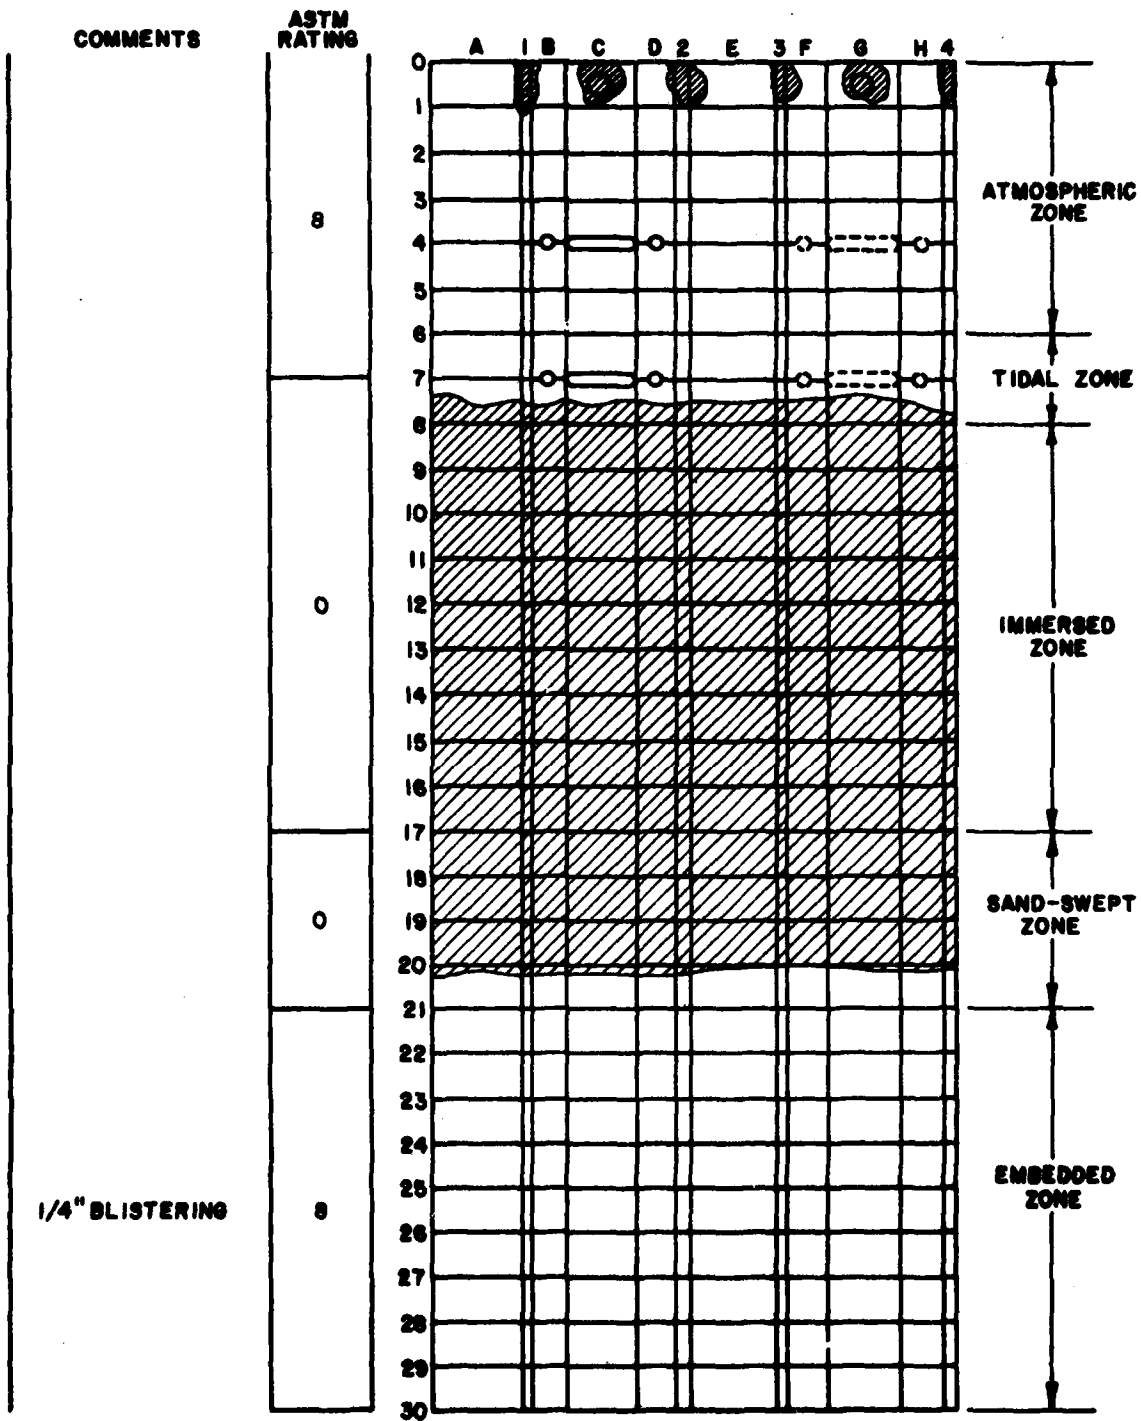
PILE NO. 21A

18. System 21 was an epoxy-tar over an inorganic zinc-rich primer. Some light rust was present along the flange edge in the atmospheric zone. There was complete loss of coating in the immersed zone, with severe rusting and pitting. The coating had blistered in the embedded zone.

BLISTERS

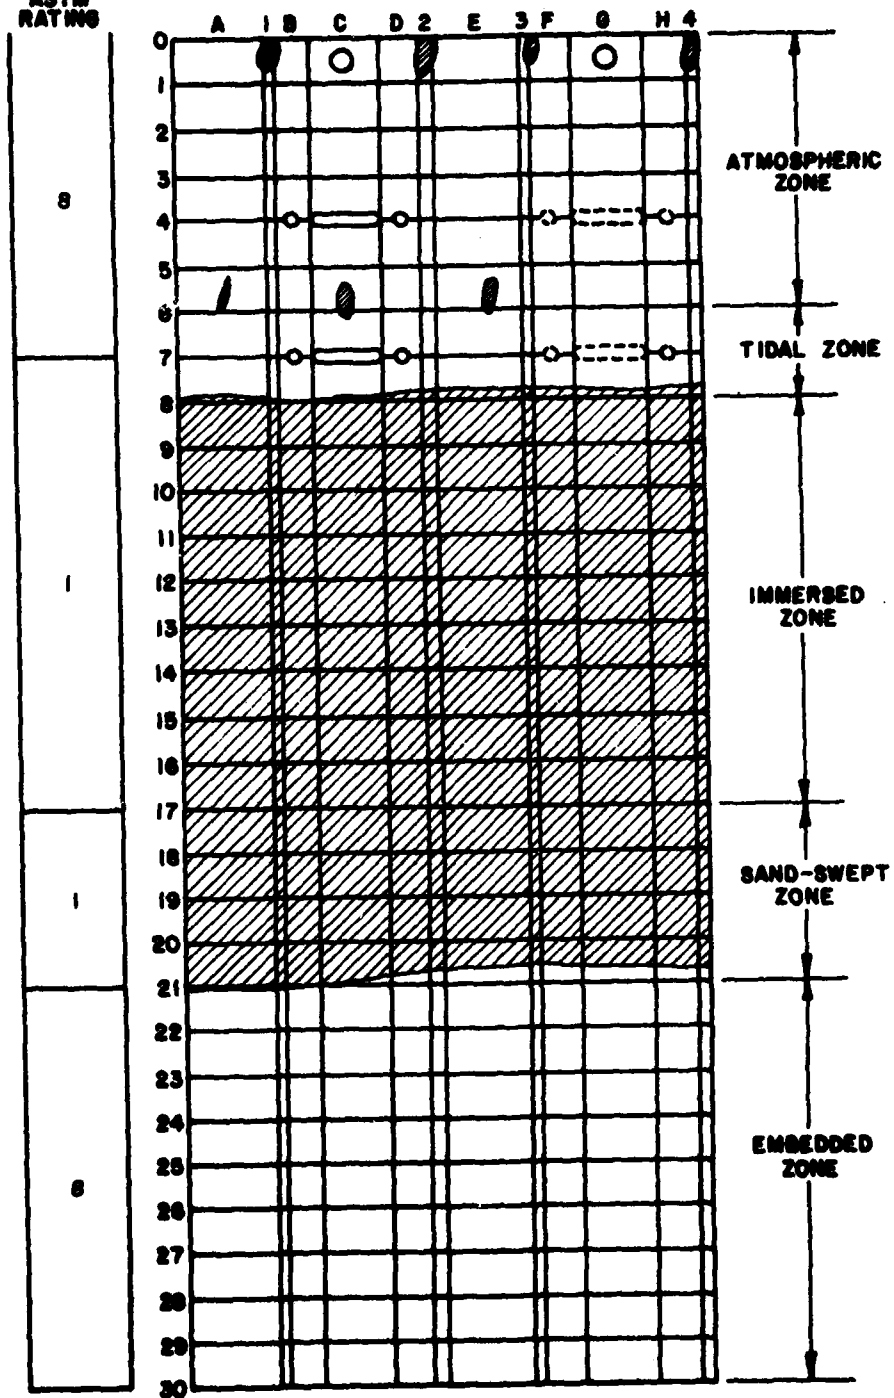
PILE NO. 218

RUST

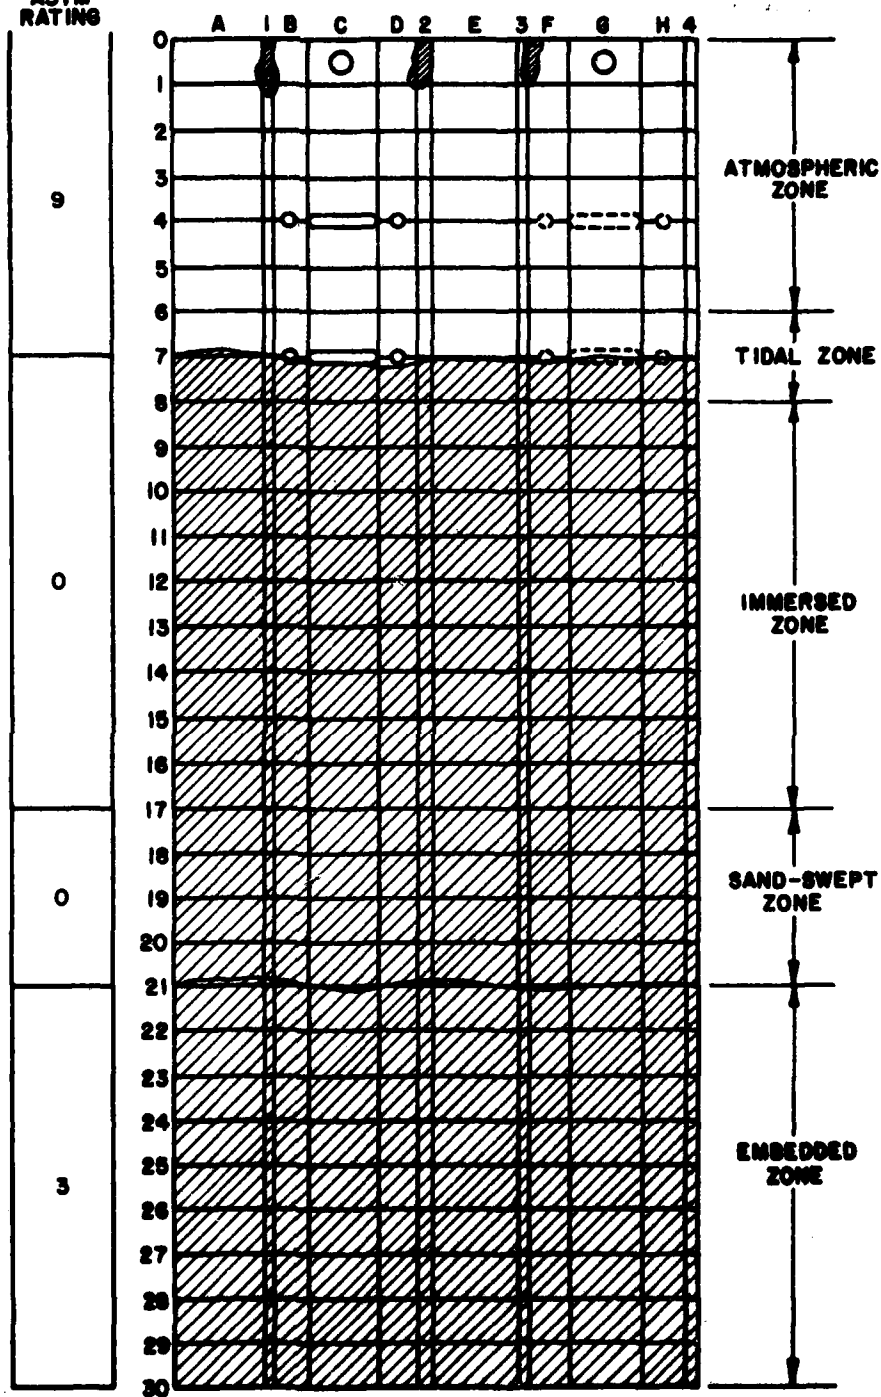
PILE NO. 22A

19. System 22 was a vinyl mastic topcoat over an inorganic zinc-rich primer. Light staining was present in atmospheric zone; complete loss of coating occurred in the immersed zone; dense blistering and rusting were present in the embedded zone.

BLISTERING &
STAINING
